The underlying causes of falls from vehicles associated with slip and trip hazards on steps and floors

Prepared by the **Health and Safety Laboratory**
for the Health and Safety Executive 2006

RESEARCH REPORT 437

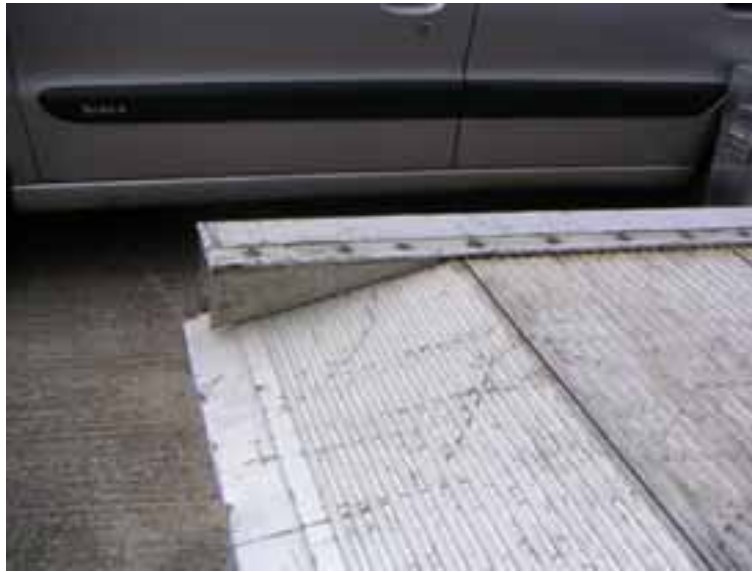
Certain tail lift designs introduce a potential trip hazard (see Fig 6). It may be foreseeable, that a driver unloading goods may walk backwards, and trip over this 'lip'. Similar platforms without this lip are in use, suggesting it could easily be redesigned to eliminate this problem.

Figure 6 – Tail lift design that could result in a trip.

In some cases, the design of tail lifts was such that the edging might pose a trip hazard (see Fig 6)

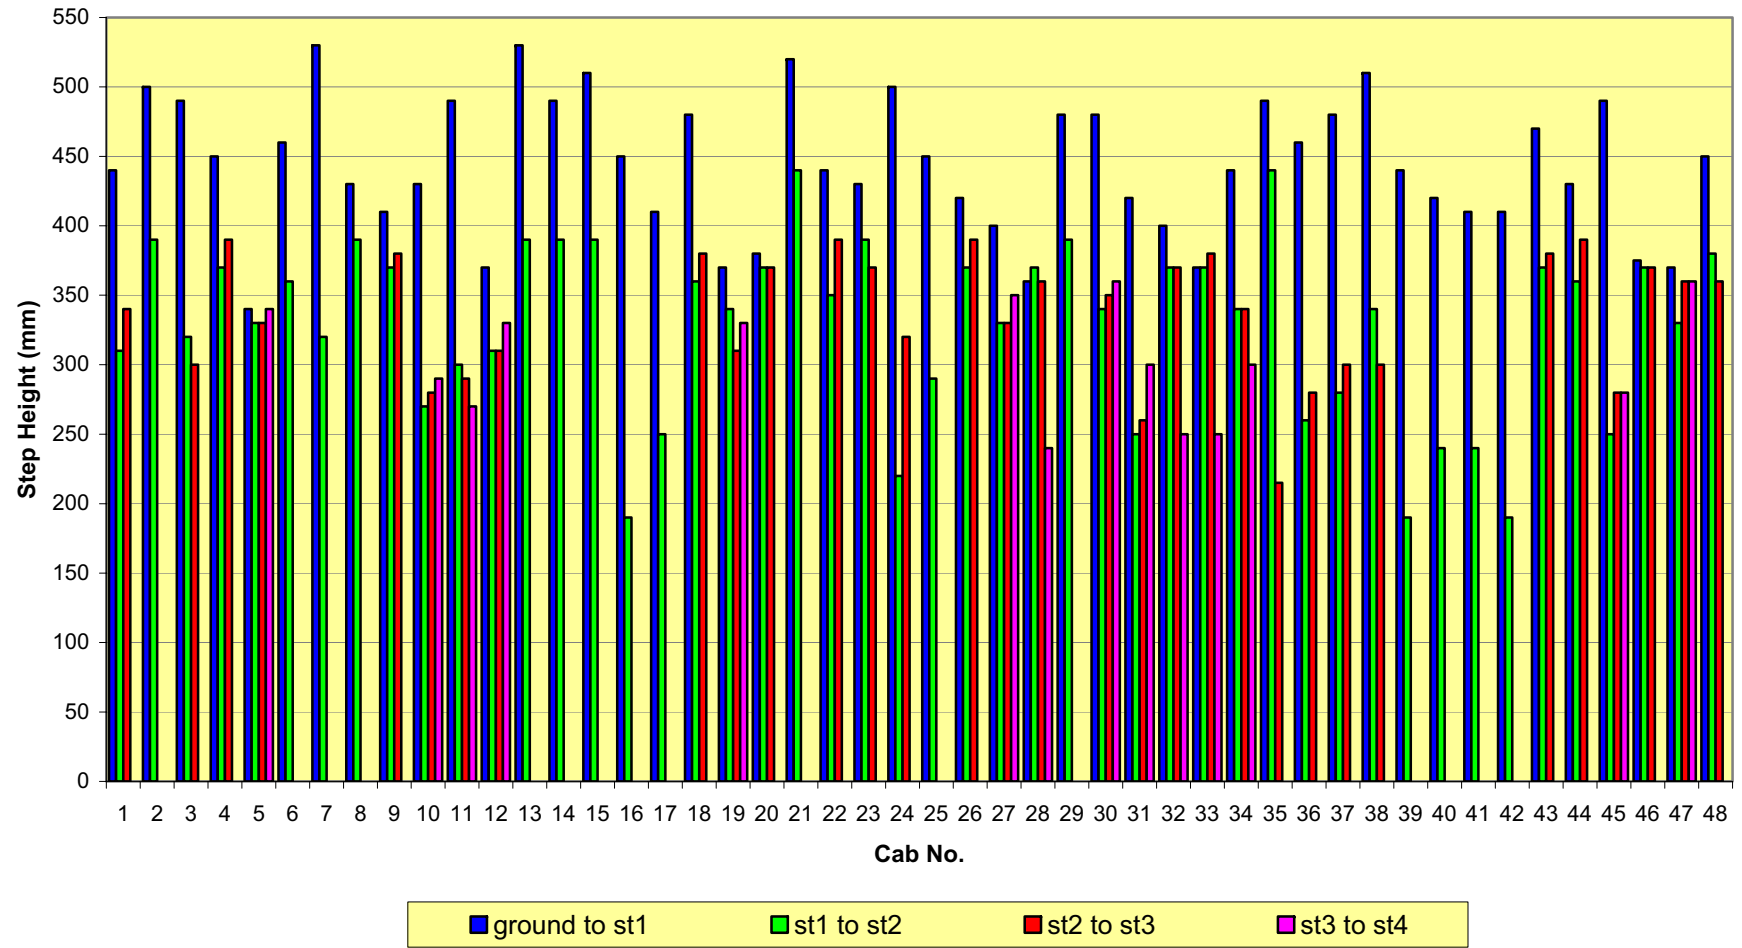
Figure 11 - Cab Step Height

A chart of the step heights for all of the cabs can be found in Appendix A, Figure 11. The largest step height was always between the ground and the first step. The smallest ground to first step height measured was 340mm, the largest was 530mm. Only four of the cabs measured had consistent step heights (cabs 5, 20, 46, 47), whilst the majority had inconsistent step heights. The majority of step heights (46 out of 48) were less than 400mm, with most falling in the range 250-400mm.

It seems intuitive that cab steps should be made as consistently as possible and within recommended dimensions as specified in related British and International standards. This will be especially important in circumstances where drivers are exposed to different cabs on a regular basis and may not be accustomed to the differences in dimensions between vehicles. Caws et al (1999) commented on the differences in quarry vehicle designs. They described how drivers that changed vehicles infrequently might expect handholds and step positions to be the same as their usual vehicle; any design differences may thus increase the chance of an accident.

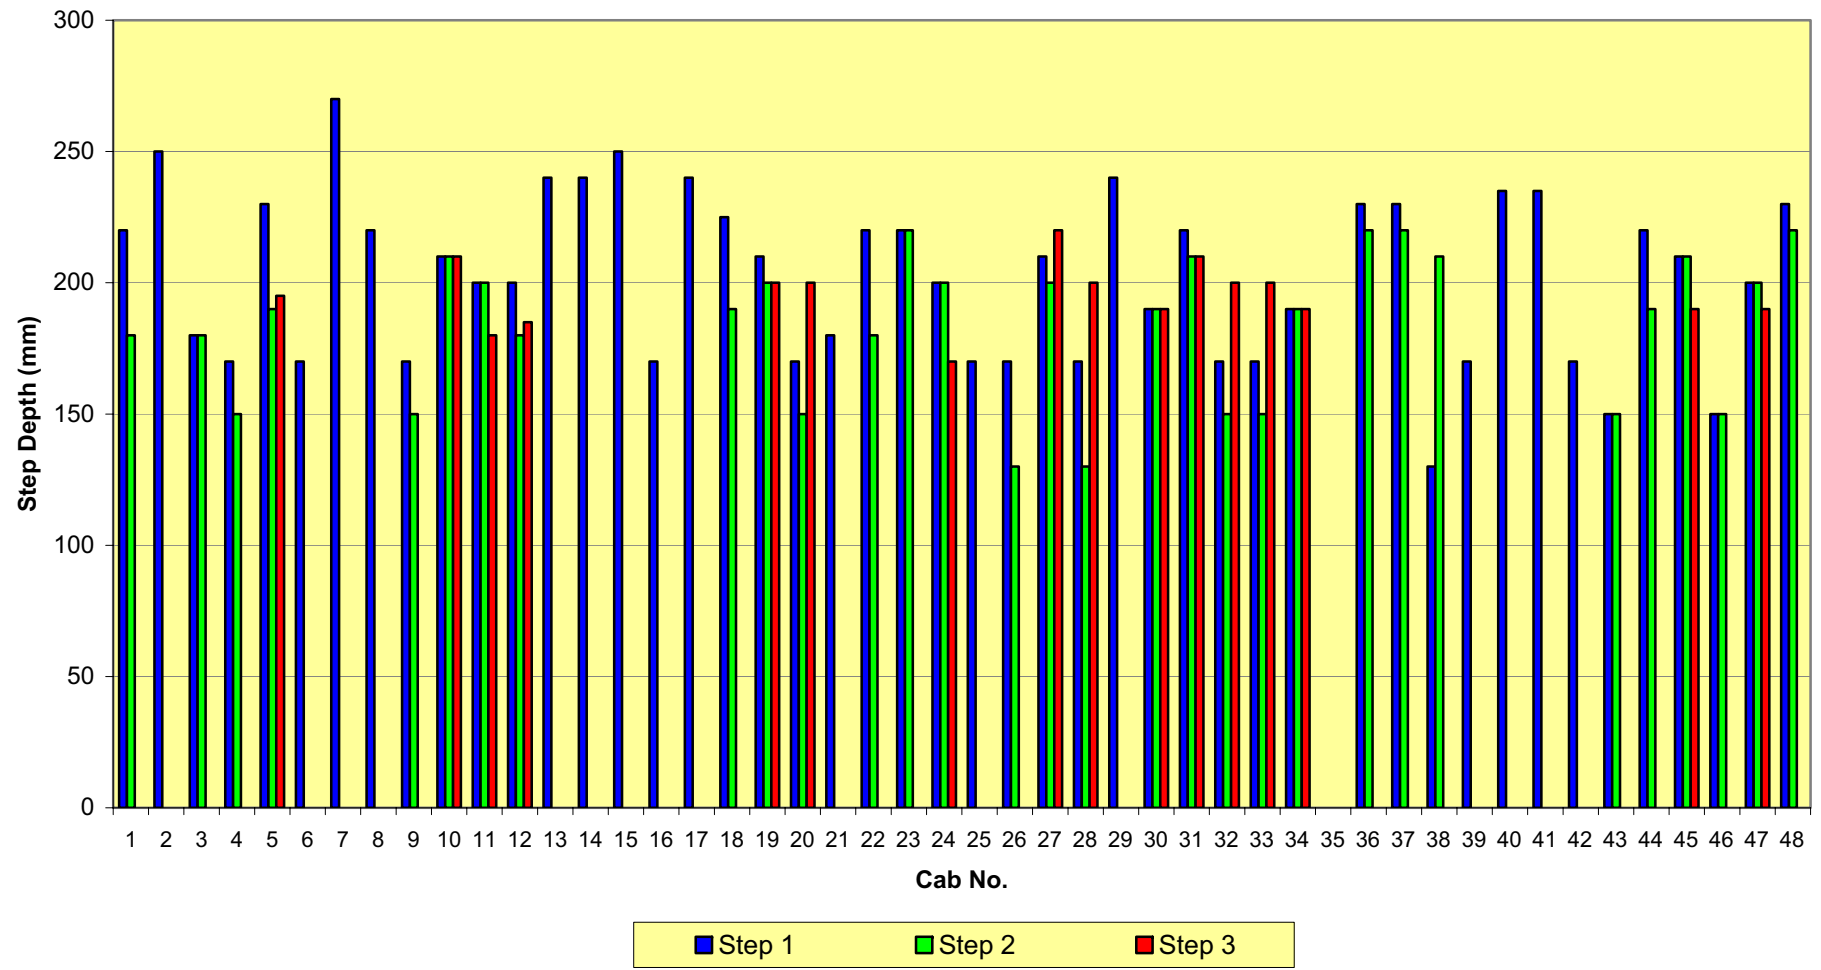
Figure 12 - Cab Step Depth

A chart of the step depths for all of the cabs can be found in Appendix A, Figure 12. The smallest step depth measured was 130mm, the largest was 270mm. In general terms, the larger the step depth the better the likelihood that a user can gain a good footing on the surface. 14 of the 48 cab steps measured had step depths less than 200mm. Figure 2 below, demonstrates how altering the depth of a stair tread affects the contact area made with the sole of the shoe. In addition, the lower schematic shows how restrictions on the height of a toehold can reduce the contact area made between the shoe sole and the step surface. BS EN ISO 2867:1999 recommends that tread depths should have basic dimensions of 200mm for steps and ladders and 300mm for stairs.

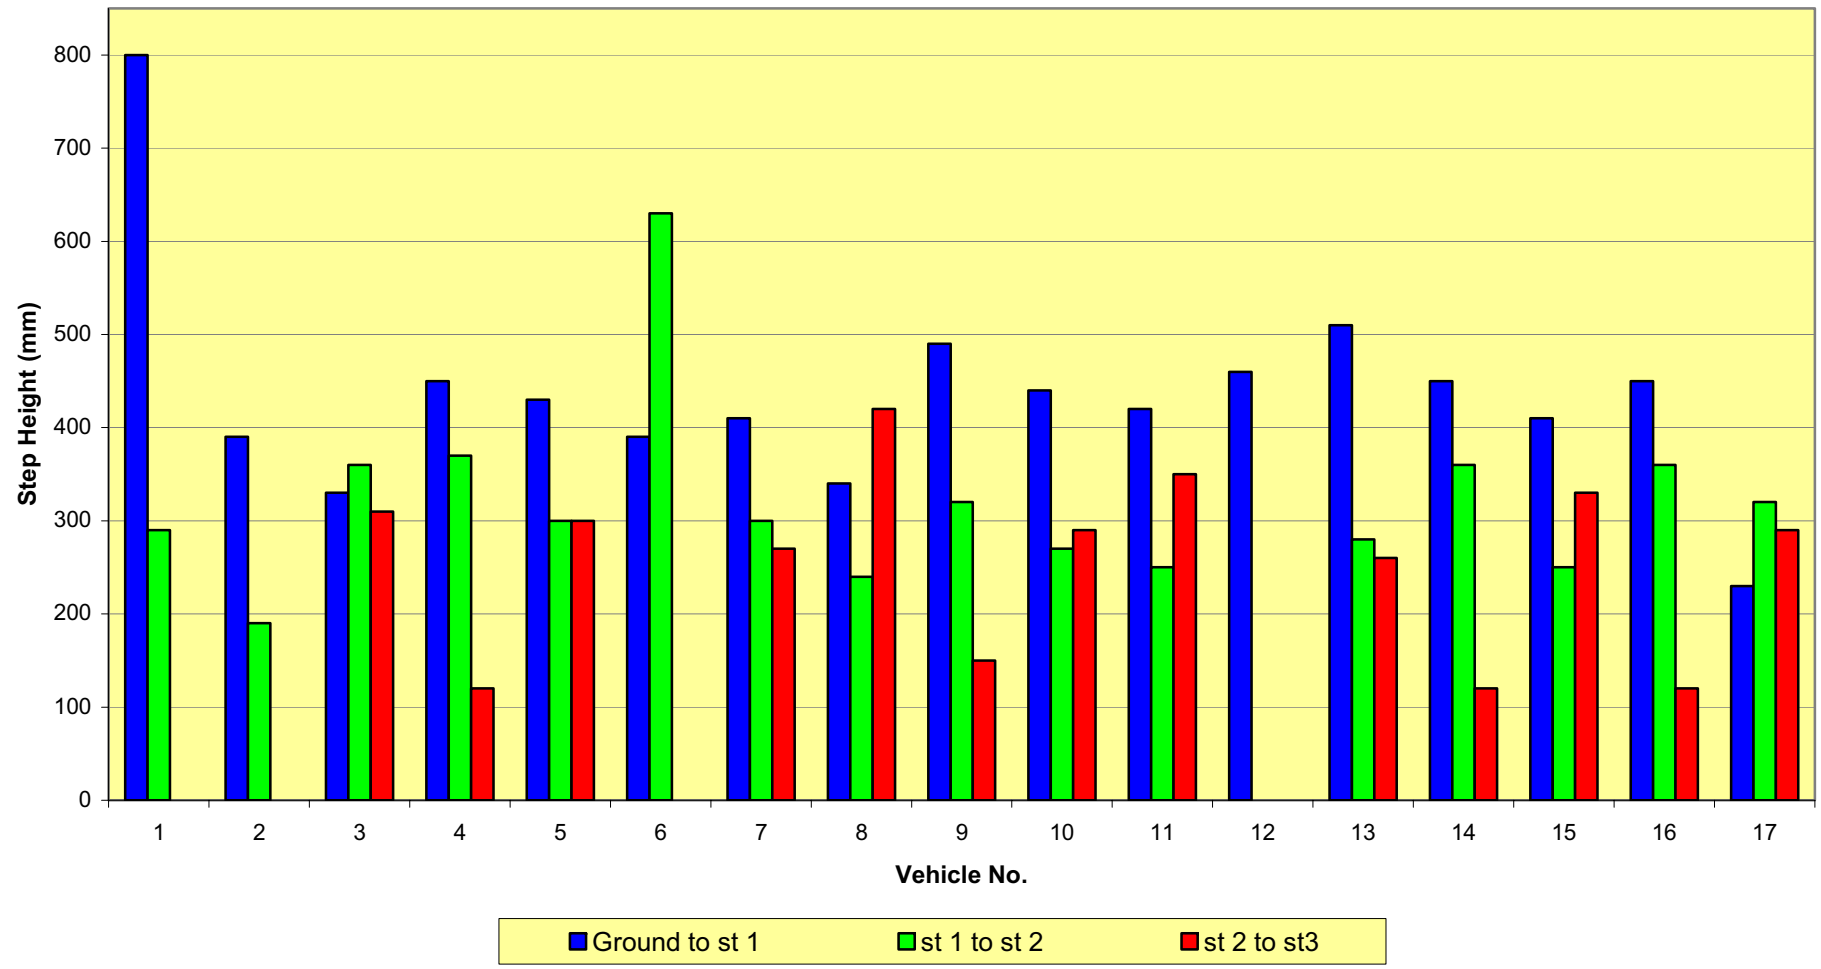
Figure 13 - 5th Wheel Step Height

Step height data for the 5th wheel area is presented in Appendix A, Figure 13. In all cases, the first step height was the greatest. A first step height of 800mm was recorded in one case, which is above the maximum step height of 700mm recommended in BS EN ISO 2867:1999 for earth moving machinery. The lowest step height measured was 120mm. In some cases, there was considerable variation in step heights for the 5th wheel region (e.g. see vehicle 9 in Figure 13). The step depths measured in the 5th wheel area tended to be relatively narrow, with 100mm being a common measure.
