The underlying causes of falls from vehicles associated with slip and trip hazards on steps and floors

Prepared by the **Health and Safety Laboratory**
for the Health and Safety Executive 2006

RESEARCH REPORT 437

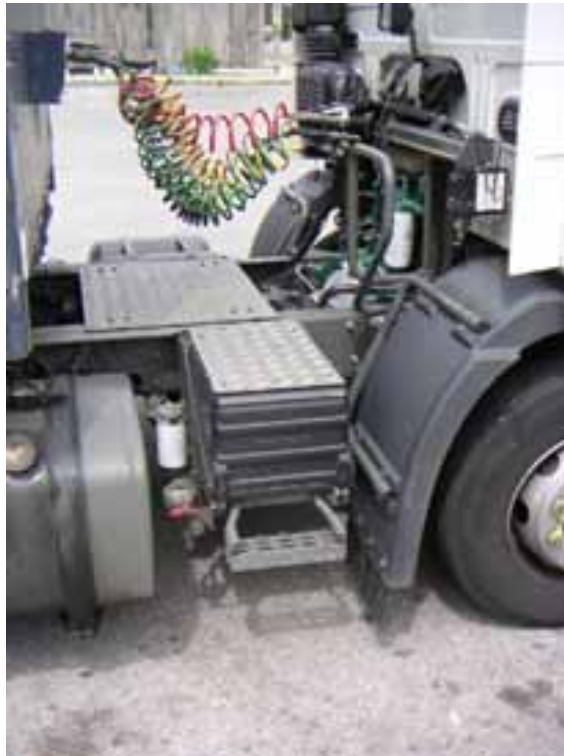
Figure 5 – 5th wheel area of an LGV

Due to its position next to the diesel tank(s) on the vehicle, the surfaces in the 5th wheel area tend to become contaminated with diesel. Drivers reported that it is easy to spill when refuelling and it was observed that on many vehicles the diesel tank and surrounding area was contaminated with diesel. Where steps are inset into the fuel tank, this makes it difficult, firstly to position the foot firmly in the constrained space of the foothold, and secondly to avoid slipping due to potential contamination by diesel.

The surfaces used in covering the 5th wheel area (including battery unit) tend to be profiled metal or plastic surfaces. Often, a ‘patchwork’ of surface materials is used such that there is very little consistency. Profiled surfaces generally offer less slip resistance in wet or contaminated conditions than is perceived by designers. Where a physical interlock with cleats on the shoe occurs, slip resistance is good. In the worst-case scenario where there is no interlock of the shoe sole cleats with the profiled surface, it is the surface microroughness of the peaks of the profile that is critical. Where a mixture of surfaces are used, a particular shoe may interact well with one surface, and poorly with another, giving the operator an inconsistent level of grip. Often, slip accidents occur when there is a significant change in available friction, such as when walking from a good, slip resistant surface to a slippery surface e.g. when walking from a dry surface to a wet surface that has just been mopped. Consistency in surfaces used adjacent to one another eliminates this potential hazard.

Sometimes, the 5th wheel region has areas that are not covered, for example between the chassis members. The reason for not completely covering the 5th wheel area may be for ease of access for maintenance purposes. However, this leaves the driver to walk on a very uneven surface, made up of chassis rails, compressed air tanks, fuel tank etc. the surfaces of which are generally smooth, and therefore slippery in wet conditions. The uneven nature presents a trip hazard.

- Spilt diesel, grease and dirt on the 5th wheel are slip hazards.
- There is often a lack of space for coupling up airlines and electrics in the 5th wheel area. Coupling up is a physical activity and requires pushing and pulling. The limited space in the 5th wheel region constrains this activity. Some drivers cope by manoeuvring the trailer at an angle, near to the tractor unit, coupling up the lines, and then reversing to properly join the two units. This practice is dangerous because the braking system is not fully secured and there is a risk that the trailer may move, and is discouraged by the HSE (HSE, 2002).

Suggestions were put forward to improve the functionality of the 5th wheel region. Some drivers had encountered trailers with a sliding contraption which enables better access to the airlines. The suggestion of non-return valves on airlines means that less force would be needed for coupling up and therefore less space for manoeuvring would be required. Drivers felt that it was dangerous to be in a confined space with the hazard of backward pressure present. The provision of non-slip surfaces were also suggested, as were adequate cleaning facilities for removing grease and diesel spills.
